Field Report for Airborne Data Collected In Support of US EPA Region VI TPC Fire 27 November 2019

On 27 November 2019 an explosion and subsequent fire was reported at the TPC Group facility located near Port Neches, TX. Local information indicated that at approximately 0100 (local) a large explosion rocked the area. The explosion subsequently caused a massive fire at the facility in a short amount of time. Local official ordered a 1-mile evacuation order which as of 0800 on 28 November 2019 was still in effect. Reported onsite products include various olefins, butadiene, and isobutylene. The geographical coordinates of the facility are 29.9222N, 95.0547W (figure 1).

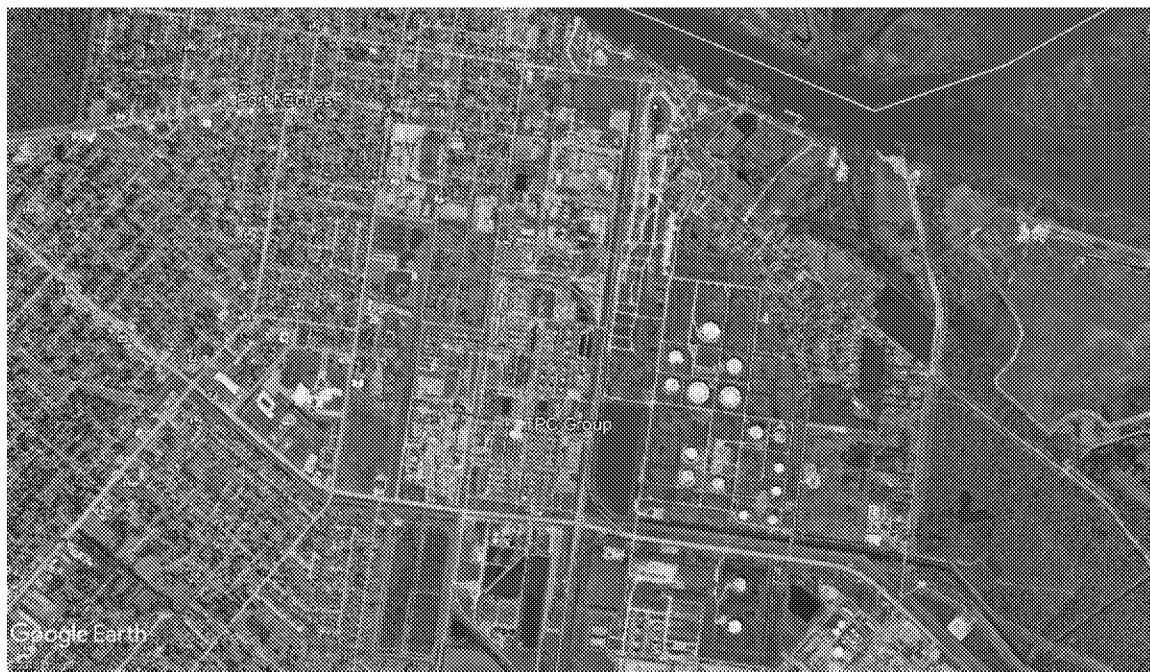
Figure 1: TPC Facility, Port Neches, TX

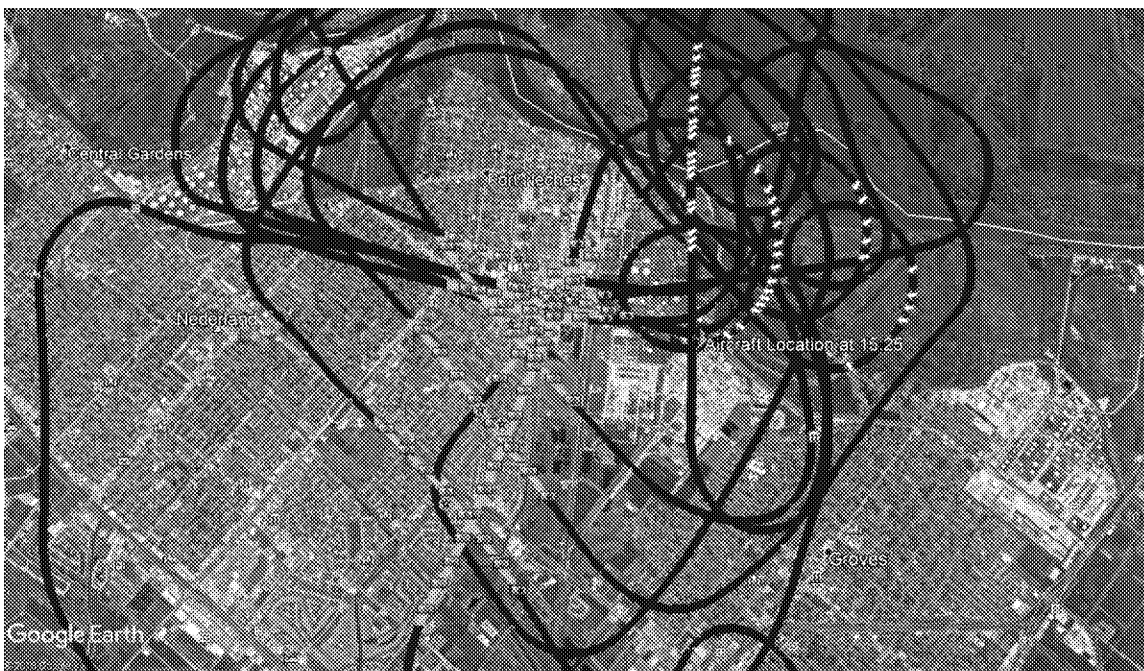
Figure 2: Data collection passes, TPC Group Fire, Port Neches, TX. The blue lines represent the ASPECT flight path, green lines represent when the FTIR was actively collecting data, the yellow icons with star is the centroid of the line scanner image, and the camera icons represent when a photo was taken.

The order to launch the aircraft was given at 0530 local on 27 November 2019 and the aircraft was airborne at 0635. The initial data collection run over the site was at 0750 (local) The aircraft made a total of 12 data collection passes; flight information is summarized in Appendix A and Figure 2.

As illustrated in figure 2, ASPECT flew several passes over and downwind of the site. Analysis of both automated and manual analysis of the data showed no significant detections. A complication which may have influenced this was that the FTIR telescope was slightly ajar in the sensor mount. After flight was completed (during a fuel stop) the telescope was checked, and the mounts tightened.

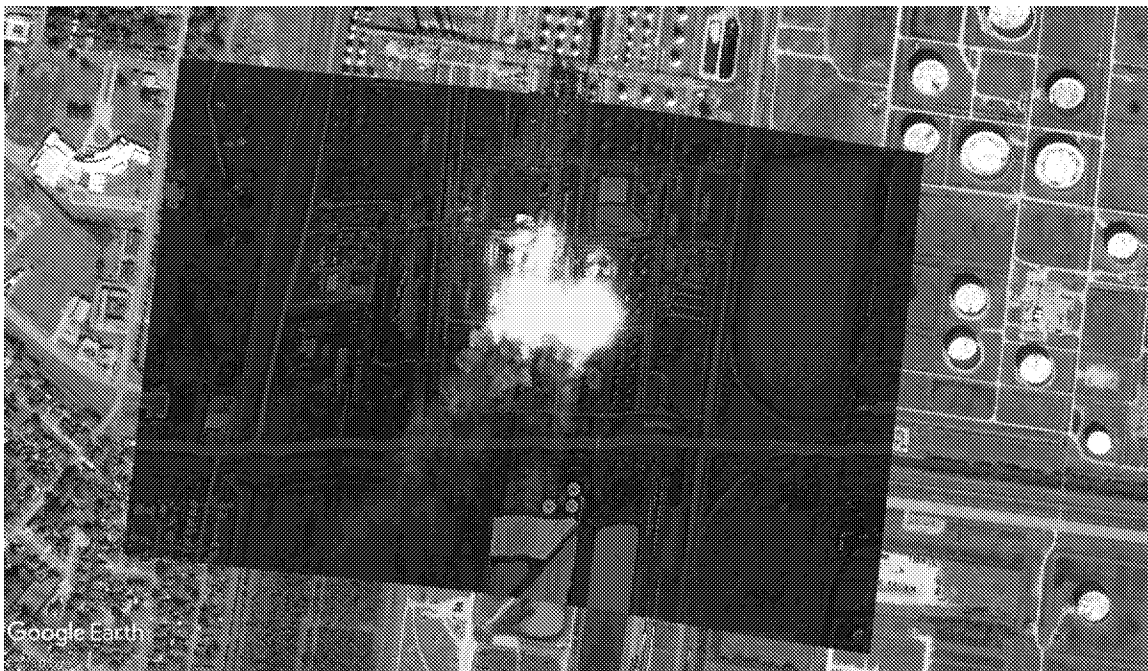
Figure 3: – 3 band IR image, Run 5, KMCO Fire, Pass 2

A total of 1 test and 11 data passes were made in the proximity of the fire and an infrared line scanner image was generated for each pass. Figure 3 shows a typical 3-band infrared image obtained from data collected for Run 2. This image was generated by flying approximately 100 meters downwind of the facility. The white area within the image is the hot signature of the fire. A thermal plume can be seen being emitted from the active fire location within the facility perimeter with no evidence of a chemical plume being generated by the fire.

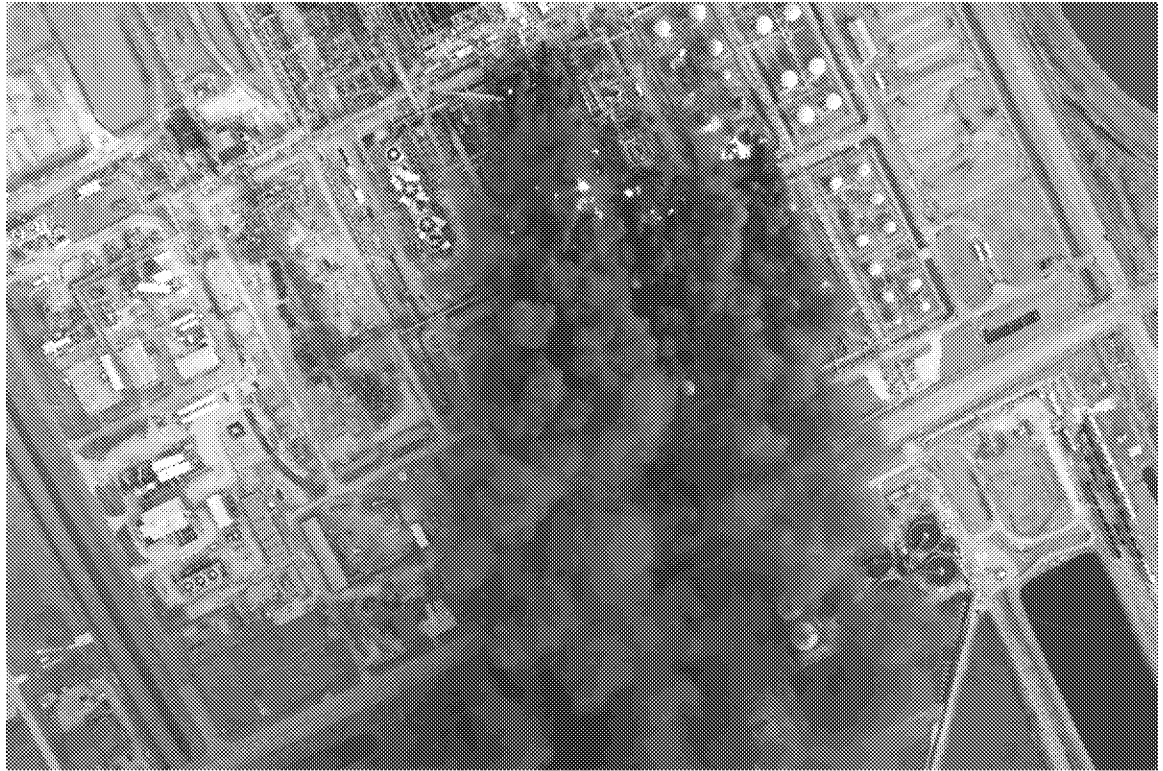
Figure 4: Aerial Image of the TCP Group Fire

A full set of high resolution aerial digital photography were collected as part of the flight. Figure 4 shows a representative image collected as part of each pass. The image illustrates that several fires are present in the field of view and the plume generated by the fire was moving to the south. Figure 5 shows a representative oblique collected from the copilot station. As with the aerial image, the frame shows multiple fires contributing to the generation of the smoke plume.

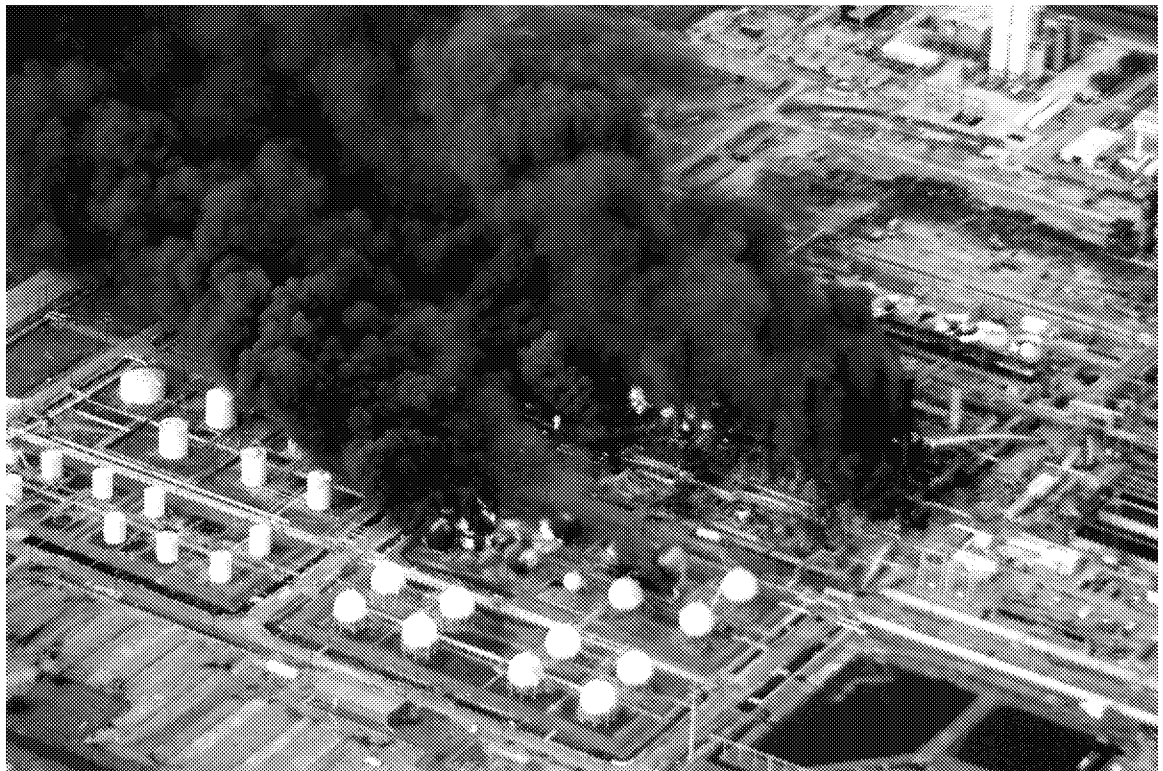
Figure 5: Oblique Image of the TCP Group Fire

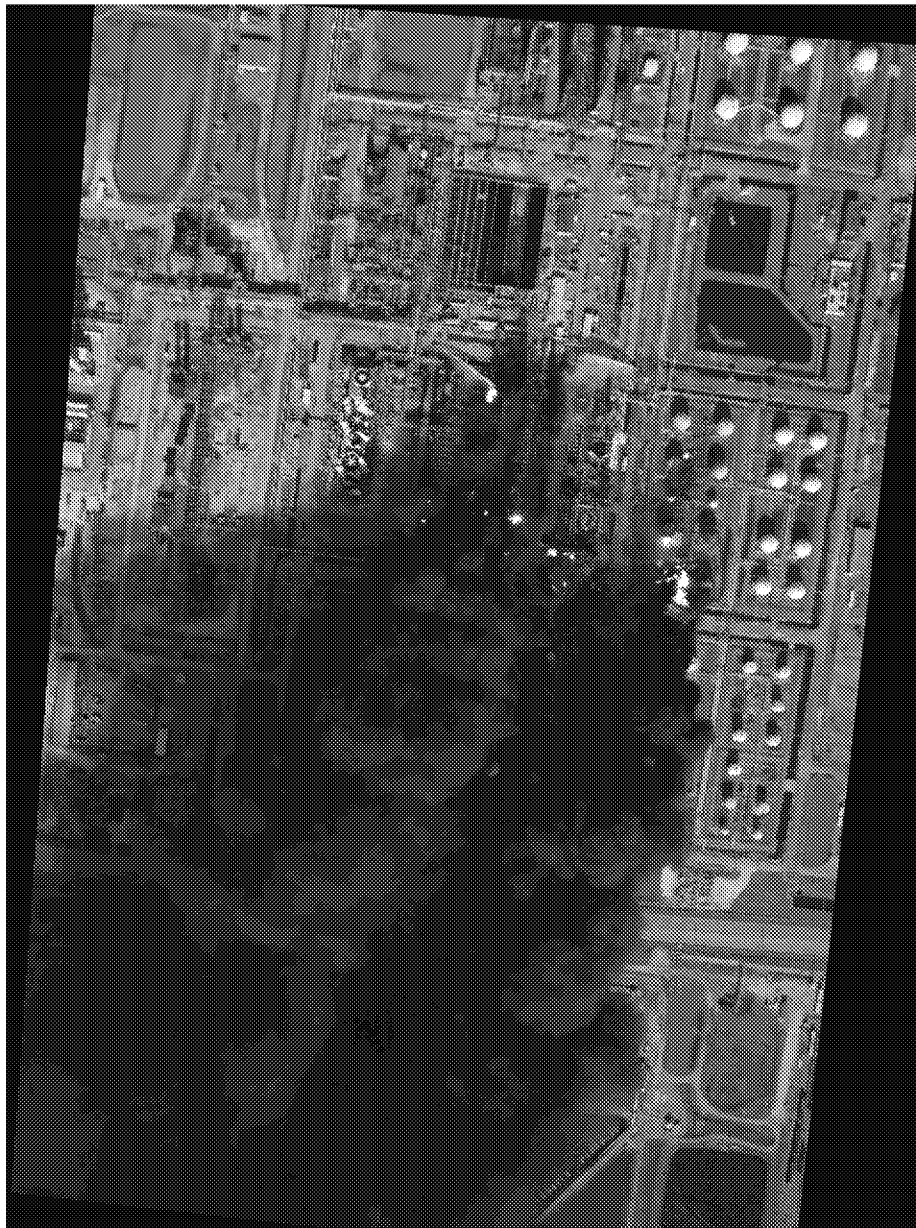
Figure 8: Aerial Image of the TCP Group Fire, Flight 2

A full set of high resolution aerial digital photography were collected as part of the flight. Figure 8 shows a representative image collected as part of each pass. The image illustrates that several fires continue to burn in the area, but the intensity of the smoke appears to be somewhat diminished. Figure 9 shows confirms that several fires are present with some indication that the number of individual fires has expanded.

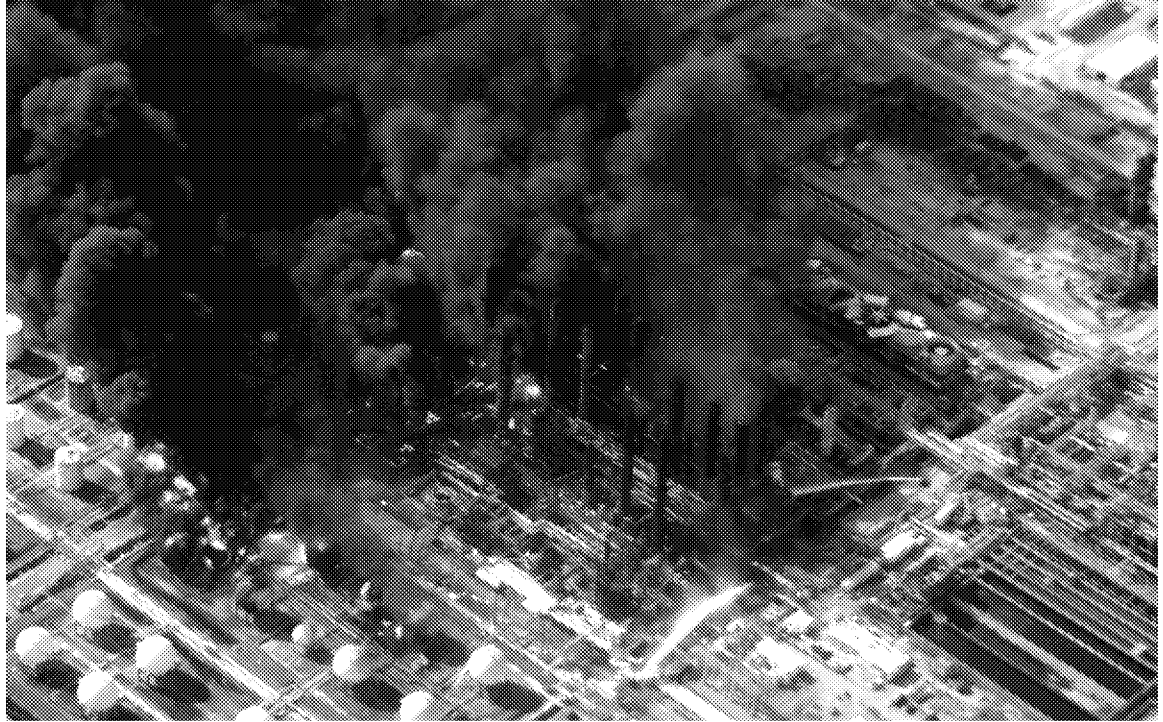
Figure 9: Oblique Image of the TCP Group Fire, Flight 2

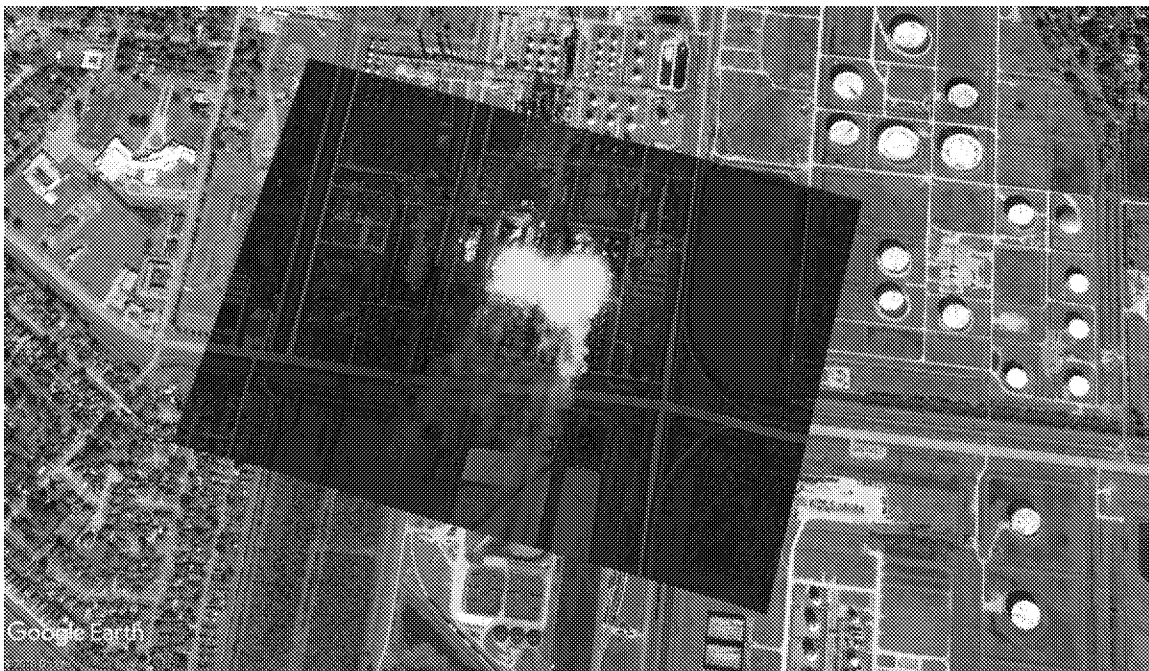
Figure 11: – 3 band IR image, TPC Group fire, Flight 3, Run 6

A total of 4 test and 3 data passes were made in the proximity of the fire and an infrared line scanner image was generated for each pass. Analysis of IR imagery generally shows consistency from early flights namely very intense heat within the field of view (figure 11).

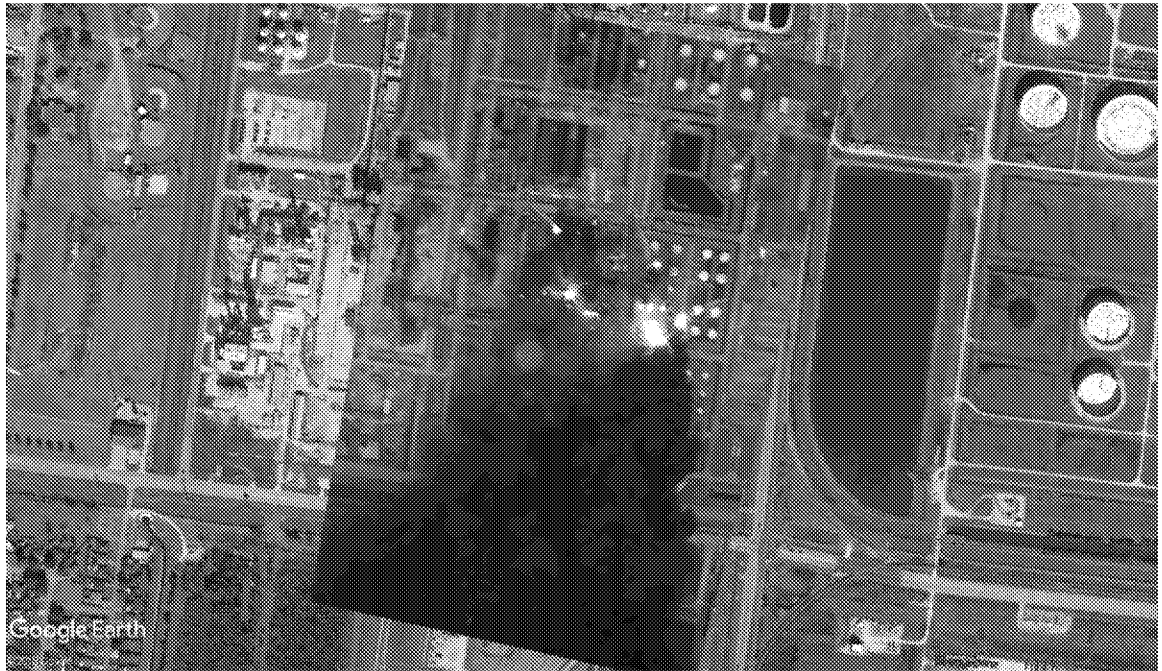
Figure 12: Aerial Image of the TCP Group Fire, Flight 3

A partial set of high resolution aerial digital photography were collected on the last flight of the day with a representative image given in figure 12. It should be noted that the image is slightly blurring due to the long exposure time needed to collect the image under low light conditions. The image shows that fires continue to burn with no apparent spreading in structures or tanks. Due to the time of day and lack of enough light, oblique images were not collected on this flight.
